AVIATION INVESTIGATION REPORT

A00Q0043

INCORRECT ASSEMBLY OF AILERON CONTROL SYSTEM

CESSNA 172L C-FAXL

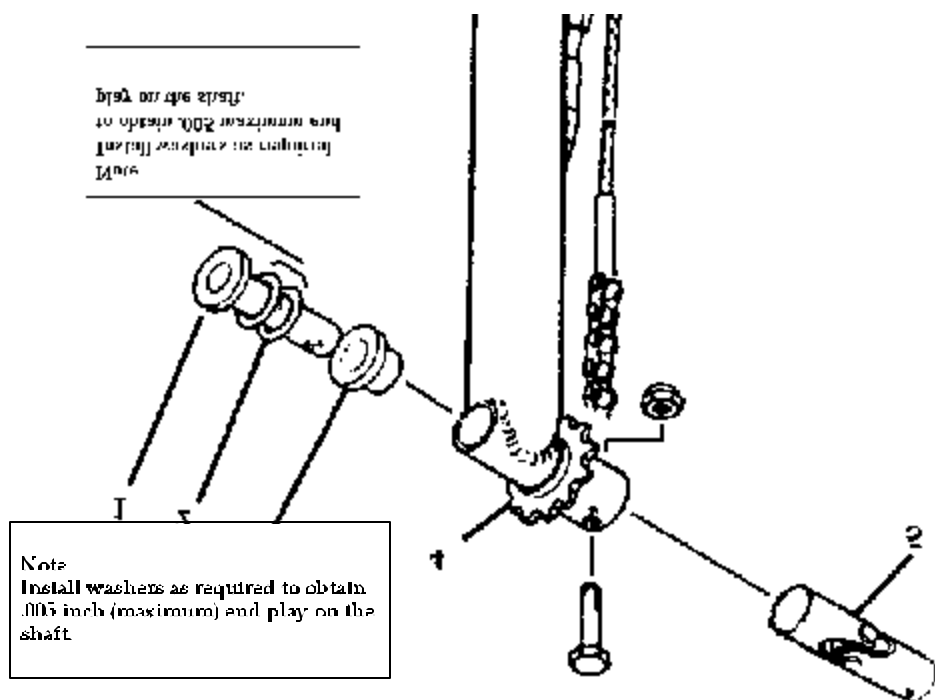
Appendix A—Aileron Control System

The work involved sliding the universal joint (part number [P/N] 0411257) into the sprocket (P/N 0511785-1), then pushing the shaft (P/N 0511788-1) into place and aligning it to install the bolt. The bolt would thus hold all the parts together. In the second occurrence, the maintenance manager had trouble aligning and inserting the universal joint in the sprocket. To ensure the integrity of the assembly, the manufacturer had added a note specifying that washers (P/N AN960-816L) were to be installed on the shaft to limit the distance between the shaft and the bearing (P/N S1004-43A) to 0.005 inch. (See Appendix A for a diagram of the aileron control system.) The Cessna 172 maintenance manual contains no specific instructions for removing and installing the universal joints. The manual describes, rather, the procedure for removing and installing the control as a whole. For a better view of the right-hand installation, the technician could have accessed all the parts by removing the card box, but he did not do so. The technician therefore had to work by feel in a more confined space.

The universal joint was held in place by the pressure exerted by the nut, even though the nut was not in the right place. Consequently, the abnormality could not be detected in the ground test of the controls. Removing the card box would have simplified access and would have helped to visually confirm the incorrect assembly. The time required to remove and replace the card box was a determining factor in this maintenance operation. The distance between the shaft and the bearing was nearly 0.500 inch, whereas it should have been 0.005 inch. Even an inspection by touch would have been able to detect this abnormality.

The investigation revealed that, in both occurrences, the aileron control system had been incorrectly installed, resulting in loss of lateral control of the aircraft in flight. The manufacturer's maintenance manual does not give any specific instructions concerning this installation; rather, the instructions are general, and the technicians have to show judgement when performing this maintenance operation. Removing the card box, however, would have afforded better access to the aileron control system not only to perform the work but also to check for correct system installation.

On 05 October 2000, Transport Canada issued *Service Difficulty Advisory* No. AV-2000-05. The advisory relates the circumstances of the incident and gives details about inspection and procedures when work is done on the aileron control yoke sprocket.
